# BNL CNG Release Investigation

NFS14 Workshop

May 6, 2014

Brookhaven National Laboratory

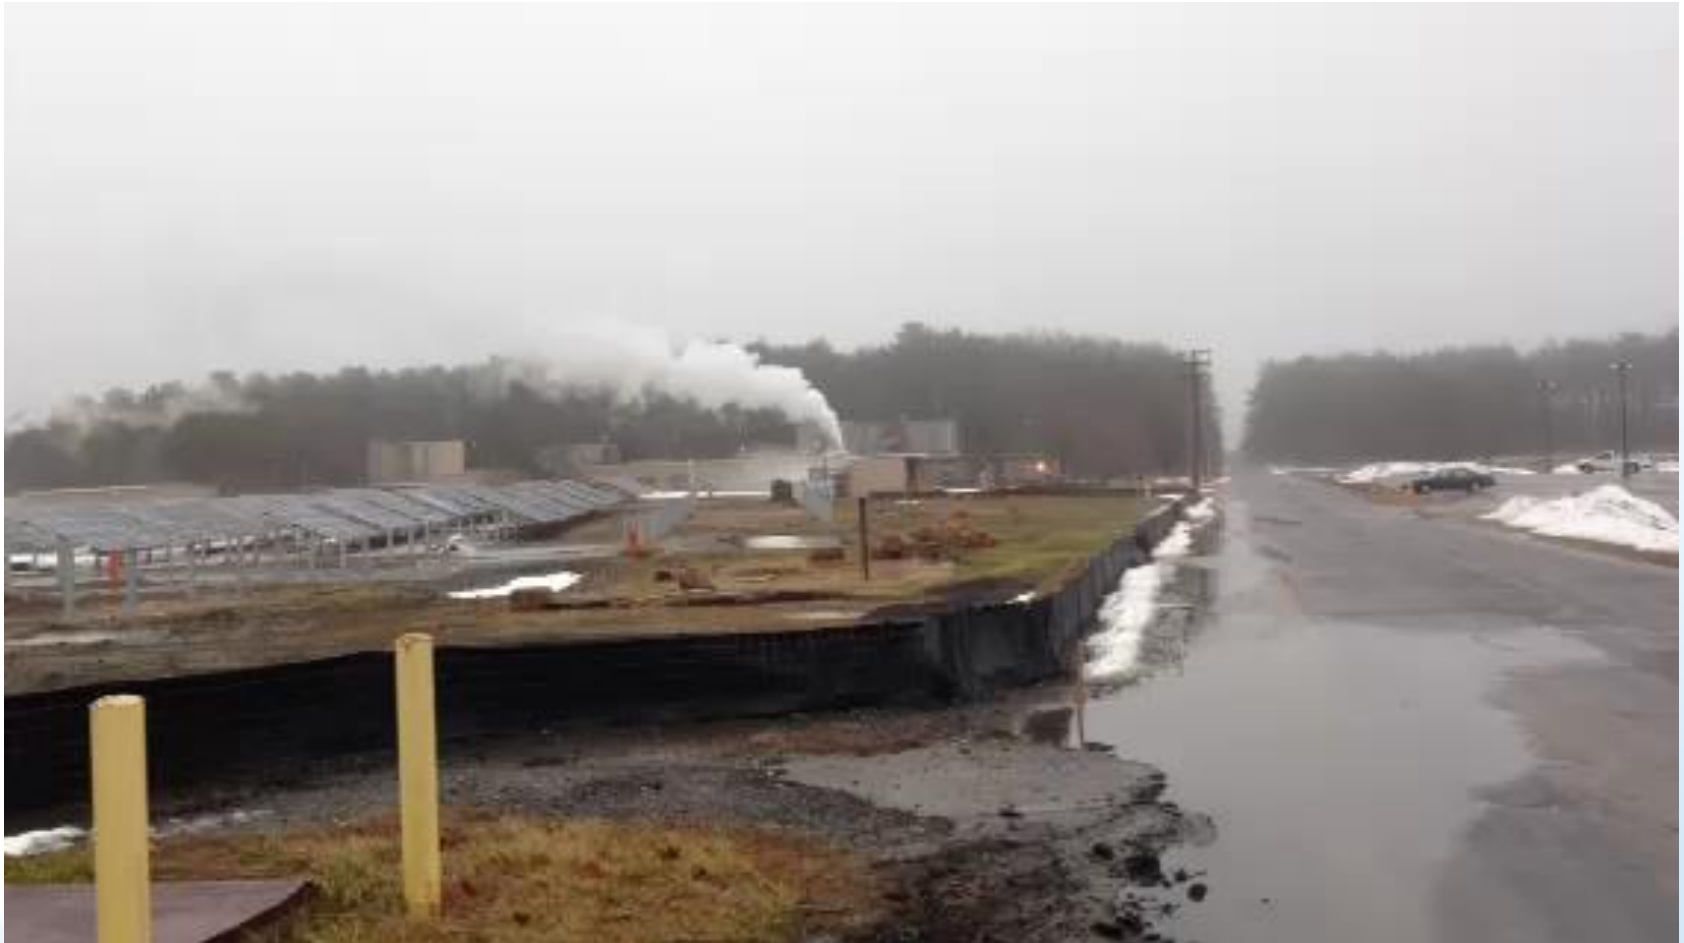
# January 6, 2014 ~7:57 AM Looking East on Brookhaven Ave.

- Monday January 6<sup>th</sup>, 2014 at 07:57 hrs.
- Call received on x2222 for a vapor cloud release at Bldg. 522
- Fire-Rescue and Police responded
- Area cordoned off
- Command Post established in B741 parking lot
- 08:10 hrs Operational Emergency declared, Request to open the EOC was made
- Shelter-in-Place ordered for zones 5 & 12
- Notifications to DOE made from the field electronically
- Emergency Stop Buttons activated
- Natural gas supply valves isolated
- Compressed cylinder pressure relief valve (PRV) isolation valves locks cut and closed (middle and bottom tank pressure relief valves still operating)
- Area gas monitor surveys conducted in B526, B528, B610
- Shelter-in-Place rescinded for zones 5 & 12
- Scene secured for Investigation
- LOTO for electric and main gas line established

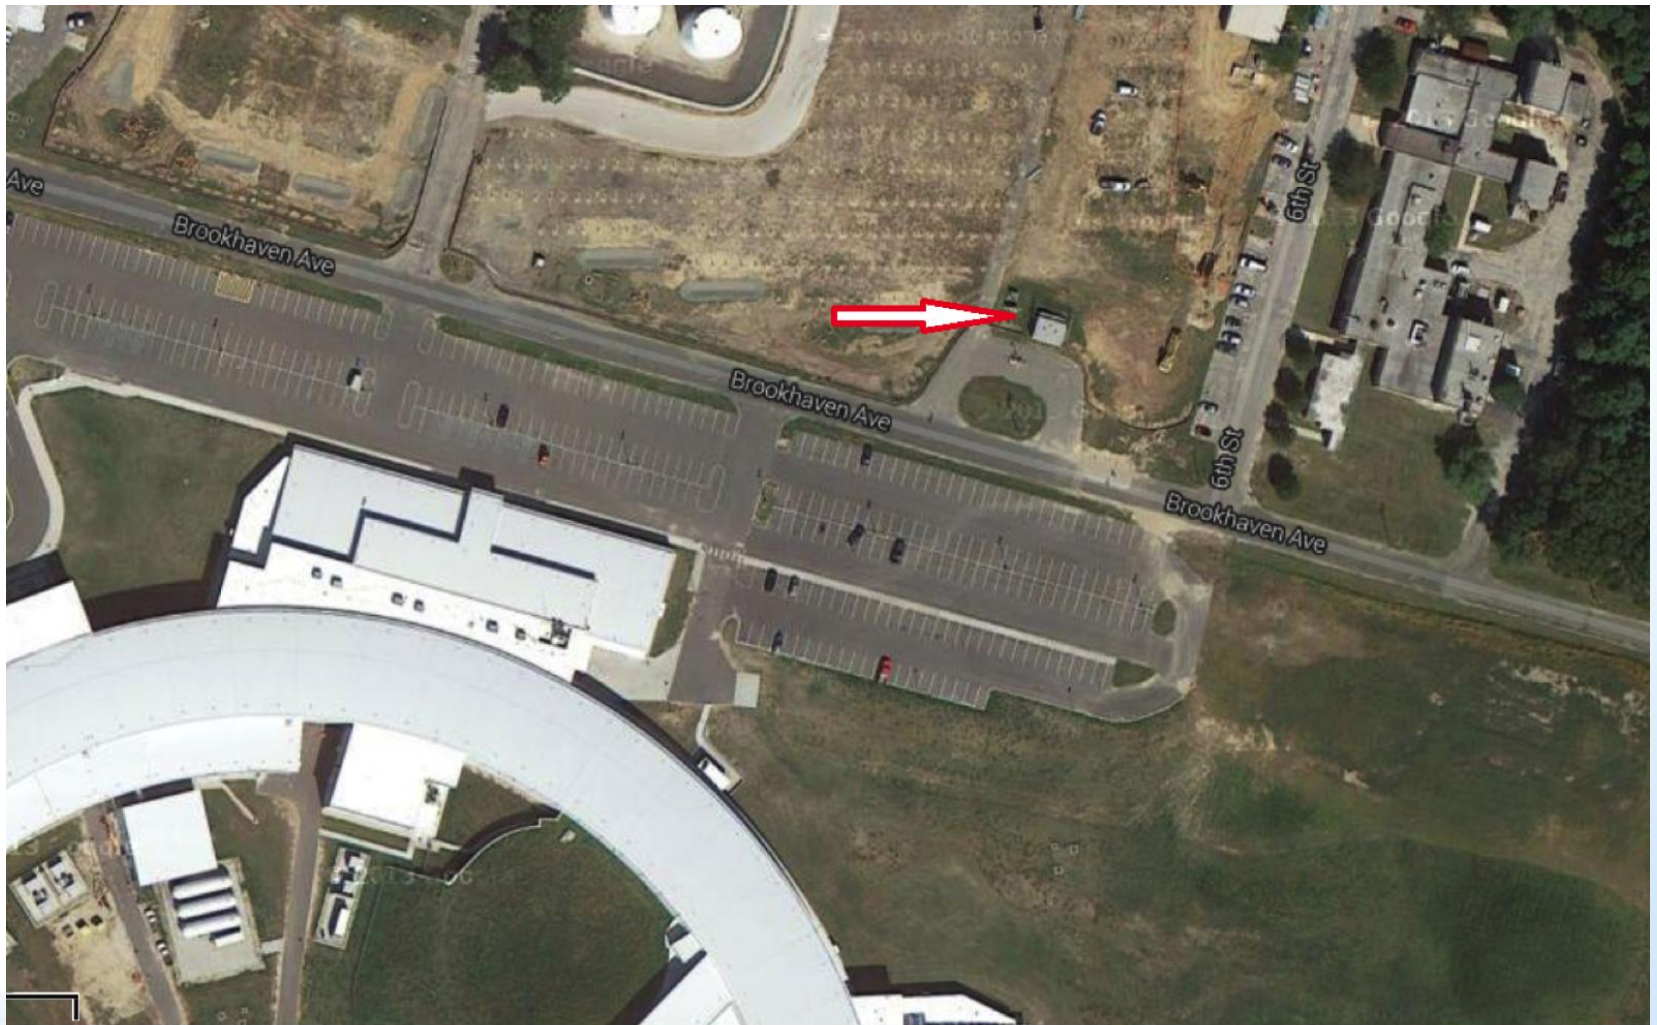
- Preliminary briefing from EOC team
- Investigation team members identified
- Initial scene survey
- Photo documentation
- Participant interviews
- Initial data gathering
- ALD for F&O schedules weekly committee briefings with management & DOE.
- Developing plan of action to temporary refuel CNG vehicles off site

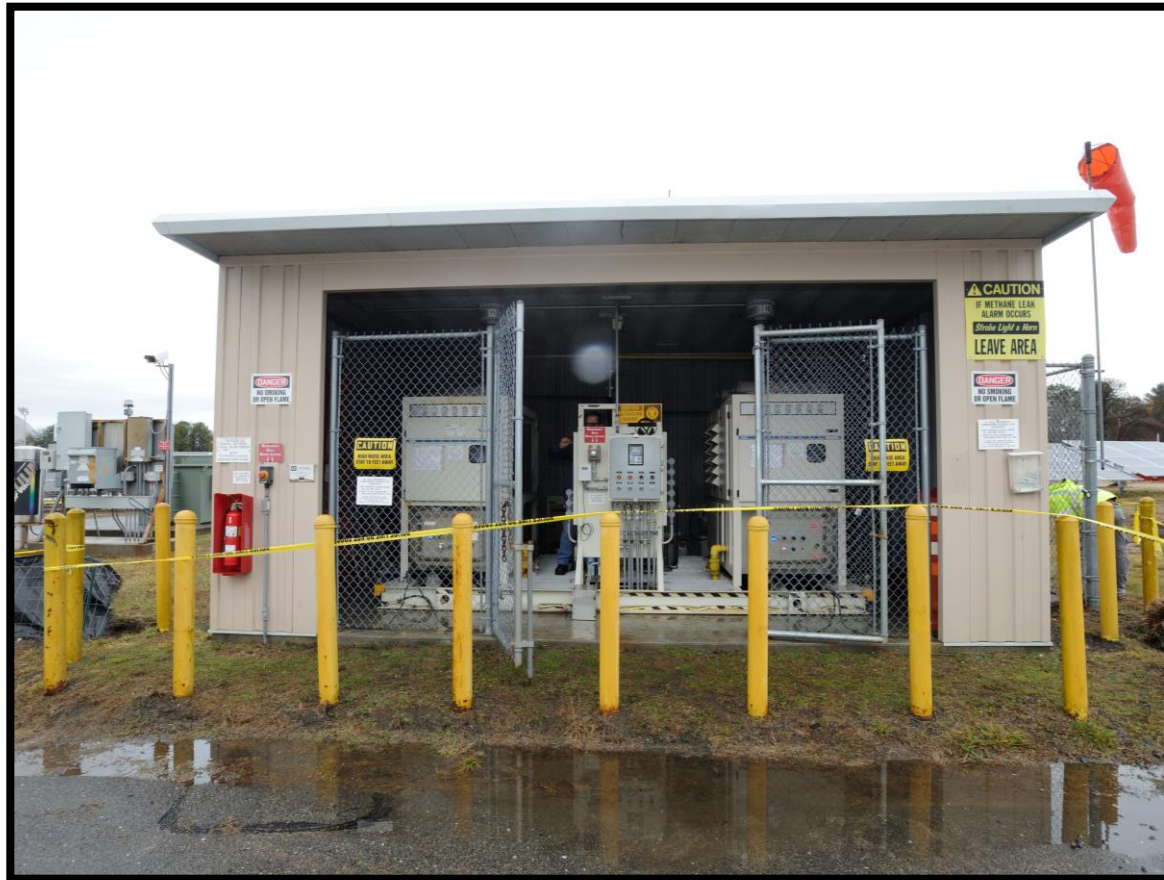
- Front View - Wide

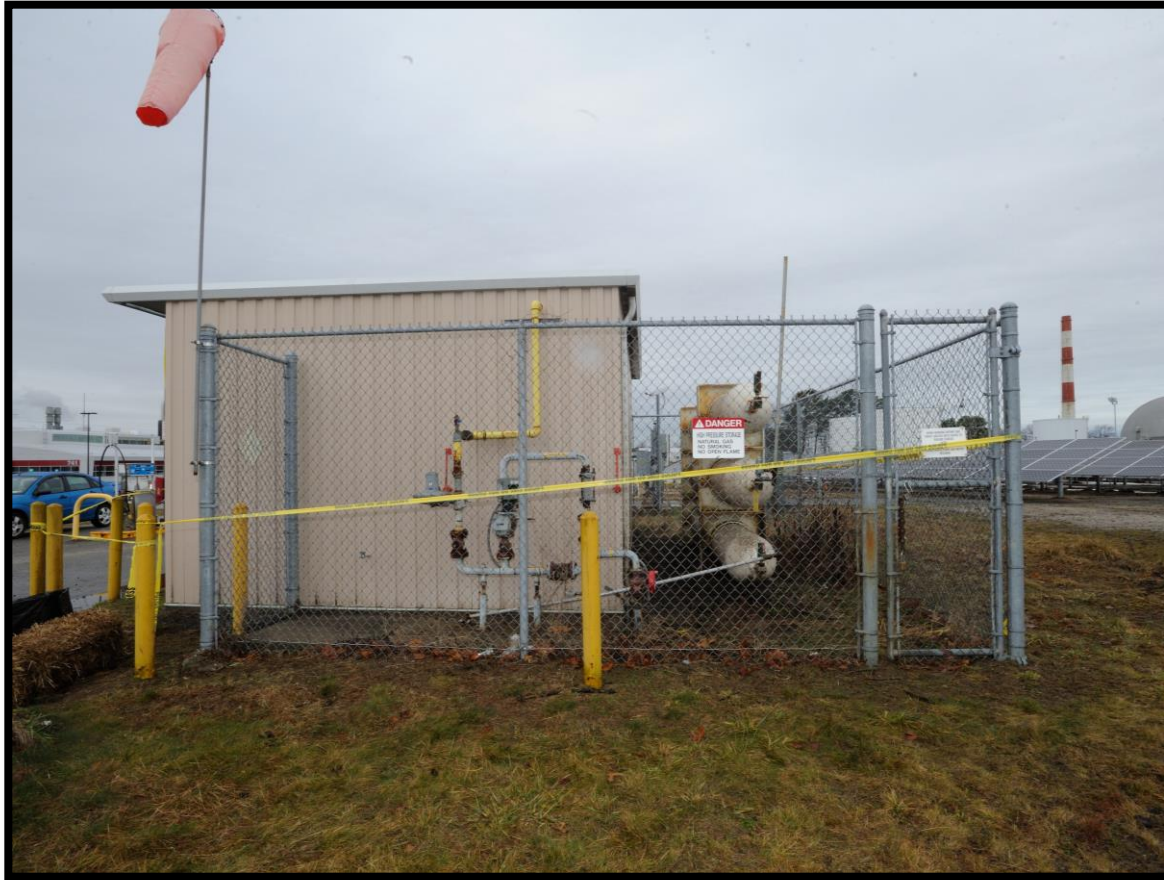
- Right (East) side

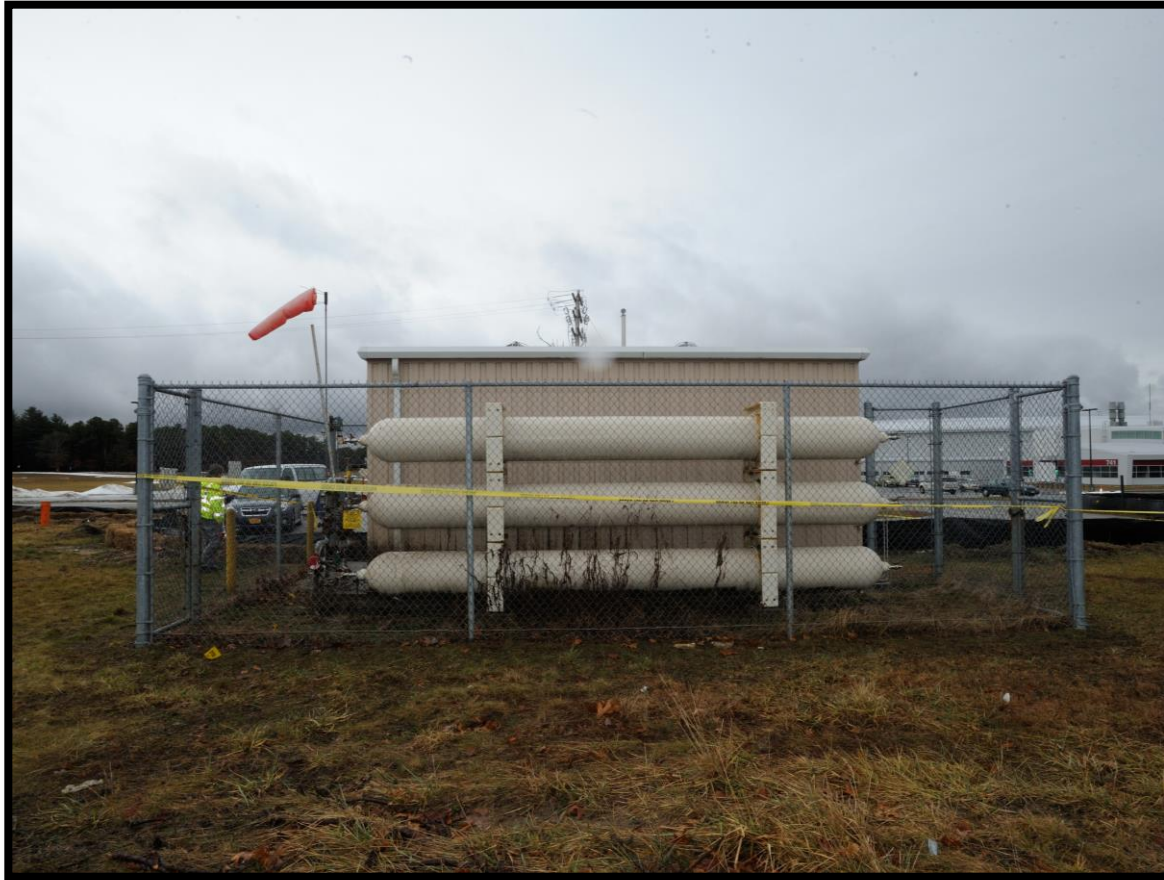
- Rear (North) side

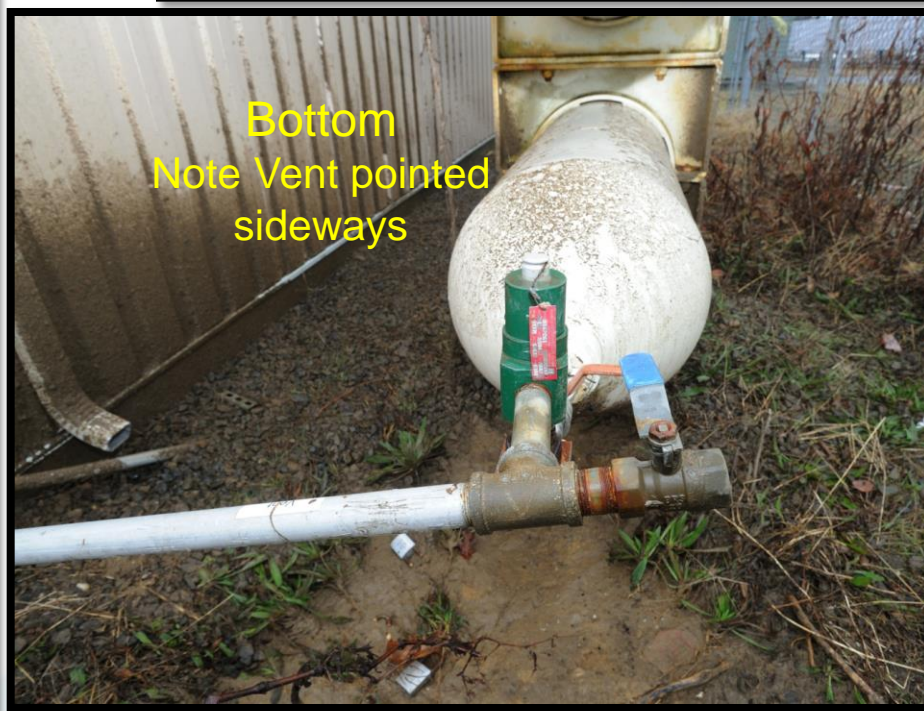
## Pressure Relief Valves after Incident

- Temperature: 56° F ;
- Wind from the South 10-12 MPH with gusts to 20 MPH
- All three Pressure Relief Valves operated. Only top relief valve appeared to reseal.
- Compressor appears to have been operating during the event after system dropped in pressure.
- Estimated release between 700 to 1,000 lbs. Below EPA reporting threshold (10,000 lbs.)

1. Calibrated less than 3 years ago
  - Set at 5,500 psig to open
  - Re-seat at 4% (~ 5,300 psig)
  - Certificates provided
2. Visual Inspection shows damage in the interior of the two valves that required Emergency Services to isolate.
3. Sent to manufacturer to determine possible cause of failure.
4. Report back from manufacturer, All three valves seats damaged from “chatter.” “Chatter” is caused by:
  1. >10% pressure in the outlet when the valve goes off.
  2. Pressure drop in the inlet of the valve.
  3. If the relief valve is oversized for the application.

2. Replace the three existing pressure relief valves with new valves. Valves will be the same model as the existing valves and designed to operate at 5,500 psi.

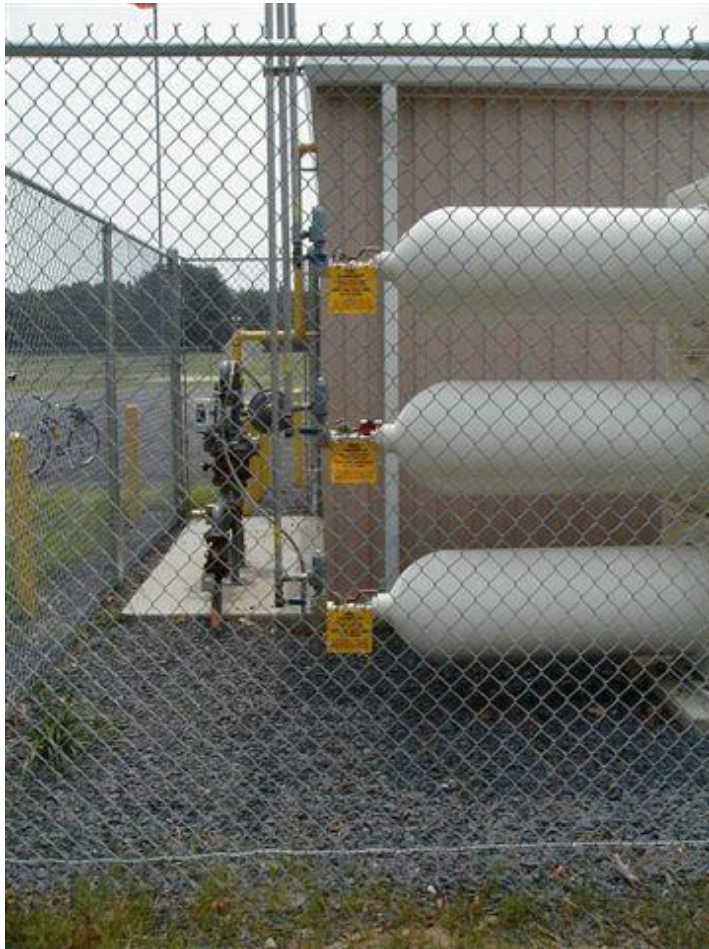
2001 DESIGN

# Pressure Relief Valve Vent Design

3. Design and install inlet and outlet pressure relief valve piping, fittings, and support system at Building 522 as approved by a New York State Licensed Professional Engineer.
